Structural Condition Report

City of Meriden
Former Meriden Hospital
1 King Place
Meriden, CT 01040

May 23, 2016

Project No. 20120232.C50

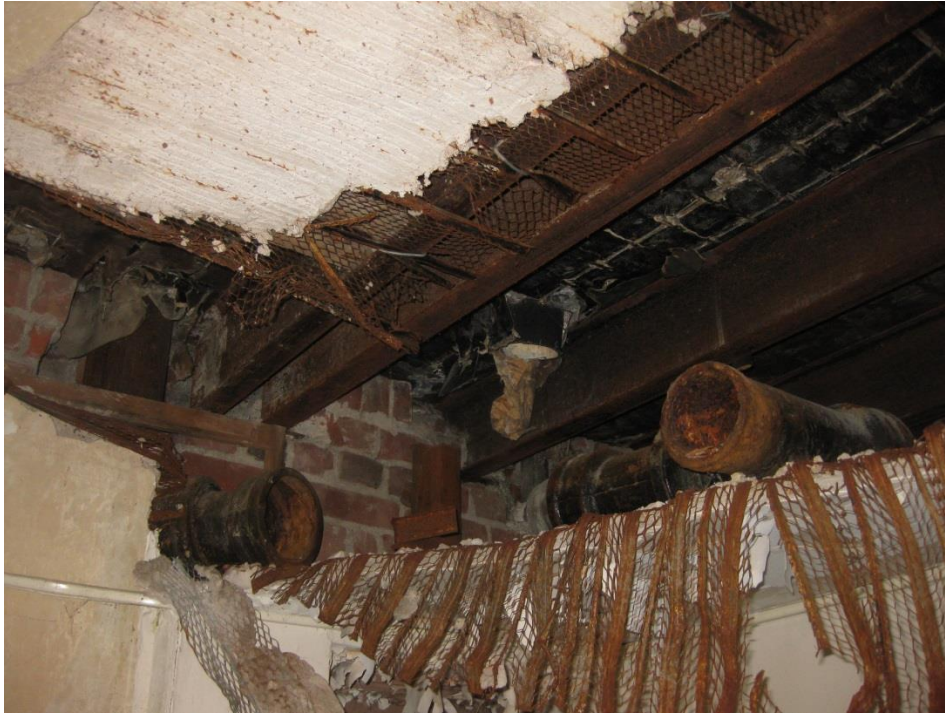
Photo A-1 - Junior Beams and Steel-Tex Floor Slab at Nurses Home

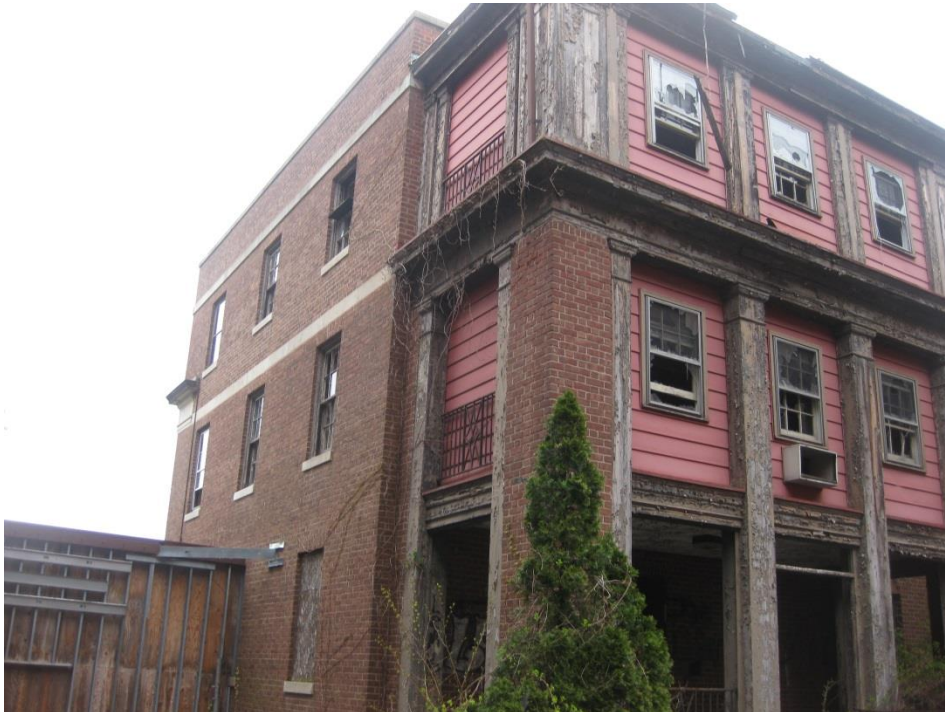
1. At the rear of the wing along Orange Street, a wood framed addition has been added facing an interior courtyard. The roof of this addition is collapsing and the floors have experienced severe water damage (see photo A-2).

Photo A-2 – Damaged Wood Structure at Nurses Home

1. Remove all damaged interior finishes to permit full visual inspection of floor and roof structures.
2. Replace damaged deck and beams, including the entire addition at the courtyard and adjacent steel-tex floor and framing.
3. Restore the building envelope (walls, windows, roofing and flashing) to prevent infiltration of water that can cause further damage to structures.
4. Wire brush all steel framed stairs and handrails in order to assess the extent of material loss.
5. Repair or replace miscellaneous steel structures as appropriate.
6. Repoint exposed exterior brick as needed.
7. Replace all existing roofs and flashing.

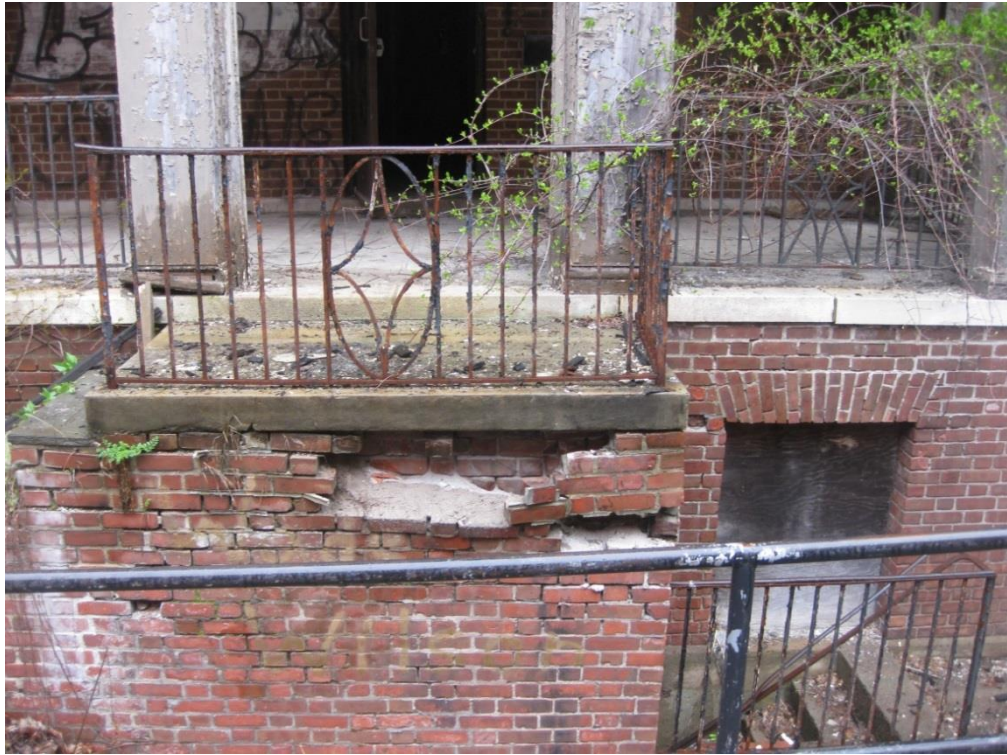
2. At the ground floor of the wood framed addition, a concrete patio runs under the building and projects beyond to a stair, with brick walls below. The brick below the stair platform is severely damaged, with cracks and displaced blocks all along the upper edge (see photo A-3).

Photo A-3 – Damaged Brick at Wood Structure at Nurses Home

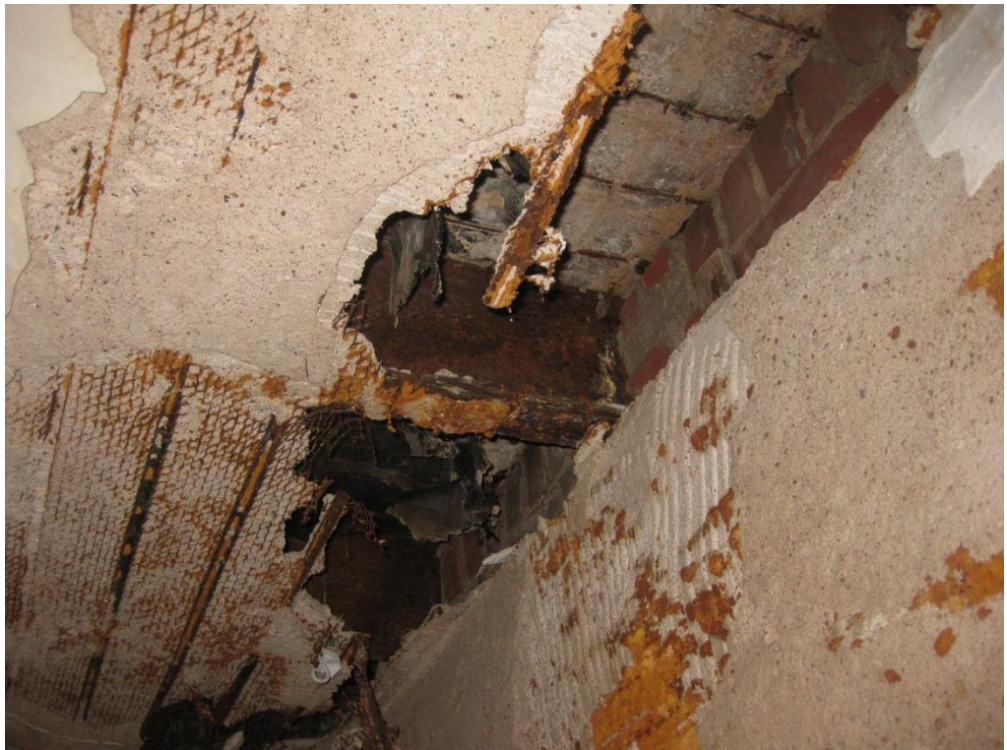
3. Significant water damage was found along the courtyard walls, with resulting damage to the junior steel I-beams where they frame into the exterior wall as well as the slab and wire in the Steel-tex (see photo A-4). Similar deterioration was found sporadically at exposed structures throughout the building.

Photo A-4 – Water Damage at Nurses Home

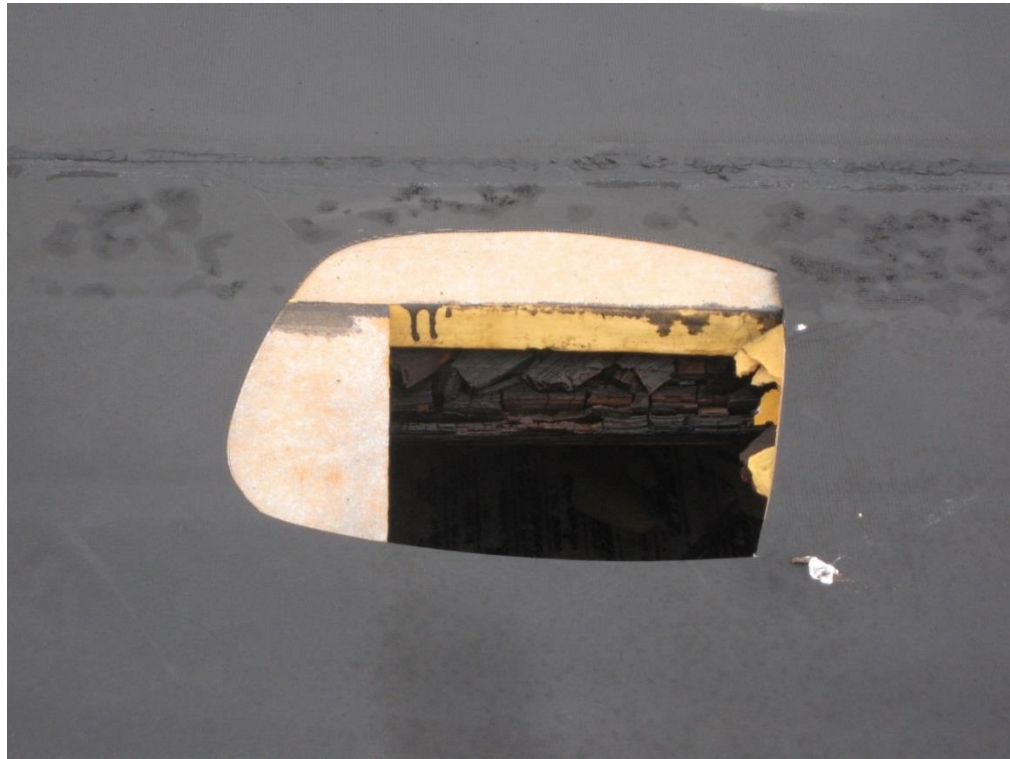
4. There is noticeable fire damage at wood framing in one remote area of the top floor towards the section of the build that abuts the 1958 addition (see photo A-5). In the area of the fire damage the exposed roof revealed a steel beam that appeared to be an addition to the existing building.

Photo A-5 – Fire Damage at Roof of Nurses Home

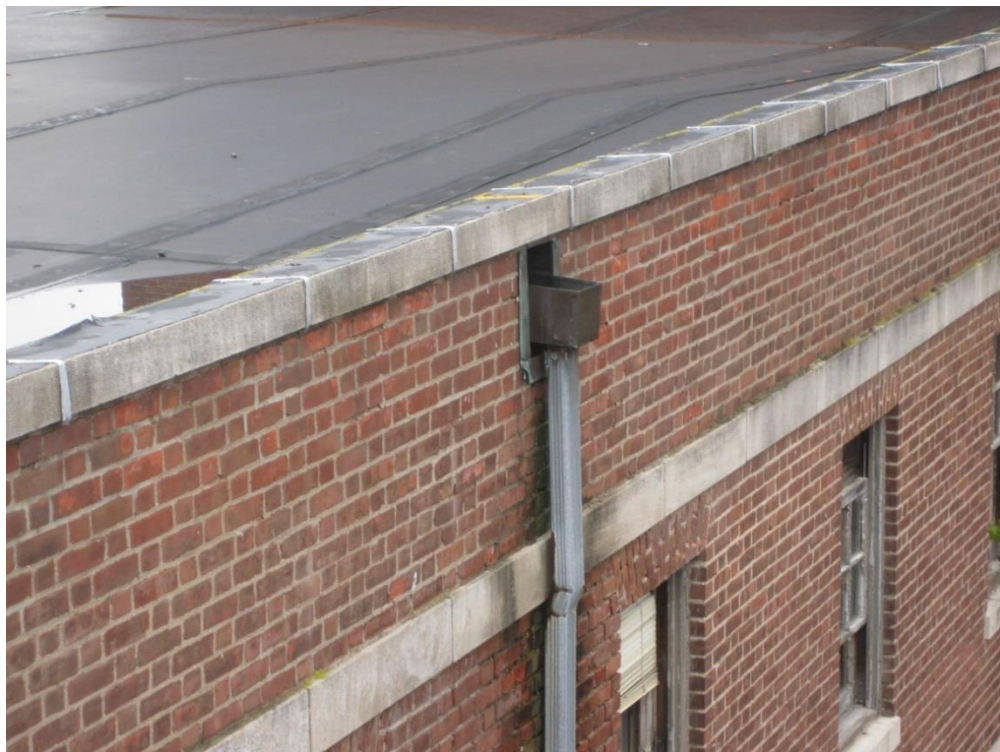
5. The roof scuppers are full of debris, which has resulted in water draining on the masonry wall. In these areas, the masonry is in poor condition and will require removal of vegetation and repointing (see photo A-6).

Photo A-6 – Roof Scuppers at Nurses Home

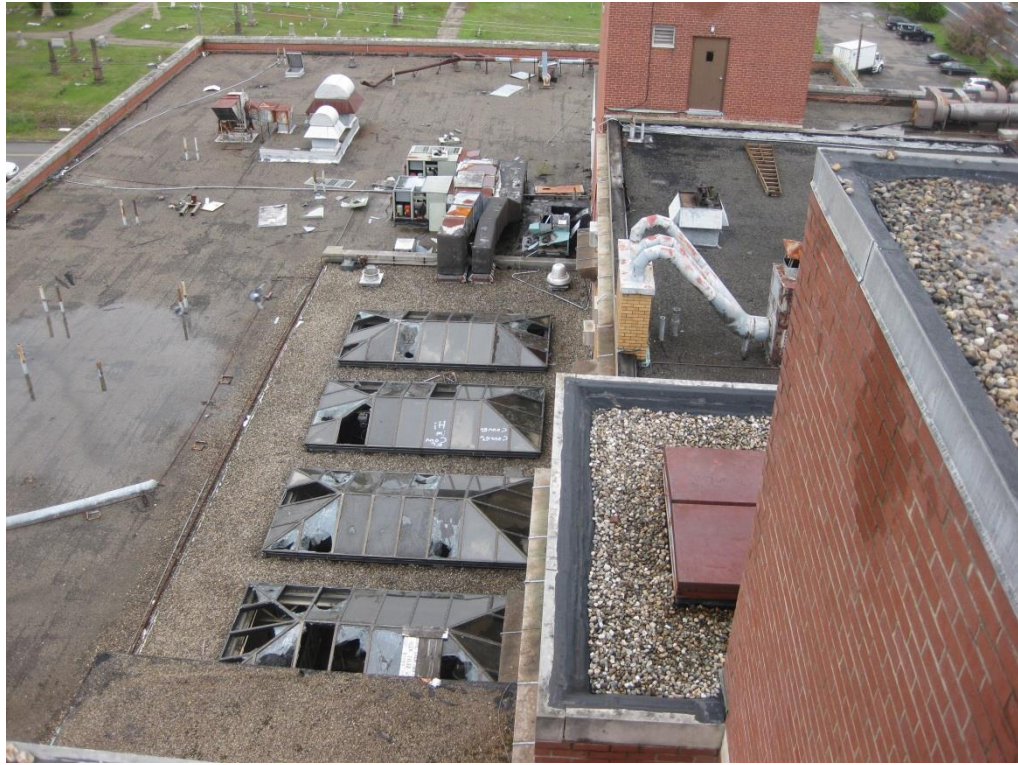
1. The roofing system has ponding water and some vegetation, especially adjacent to drains and along the perimeter (see photo B-1). Flashings are consistently failed throughout (see photo B-2).
2. There are many areas where rain water has penetrated, and exterior walls have efflorescence throughout. Some rust jacking was also noted at steel lintels.
3. The visible structure appears to be in very good condition despite the infiltration of water (see photo B-3).
4. Many miscellaneous steel elements (stair railings, support lintels, etc.) are corroded and will need to be replaced (see photo B-4).

Photo B-1 – Roof of 1966 Addition and Skylights at Atrium

1. Remove all damaged interior finishes to permit full visual inspection of floor and roof structures.
2. Restore the building envelope to prevent infiltration of water that can cause further damage to structures.
3. Wire brush all rooftop equipment dunnage, stairs and handrails in order to assess the extent of material loss.
4. Repair or replace miscellaneous steel structures as appropriate.
5. Repair or replace damaged lintels, exterior brick and associated flashing where rust jacking has been identified.
6. Repoint exposed exterior brick as needed.
7. Replace all existing roofs and flashing.

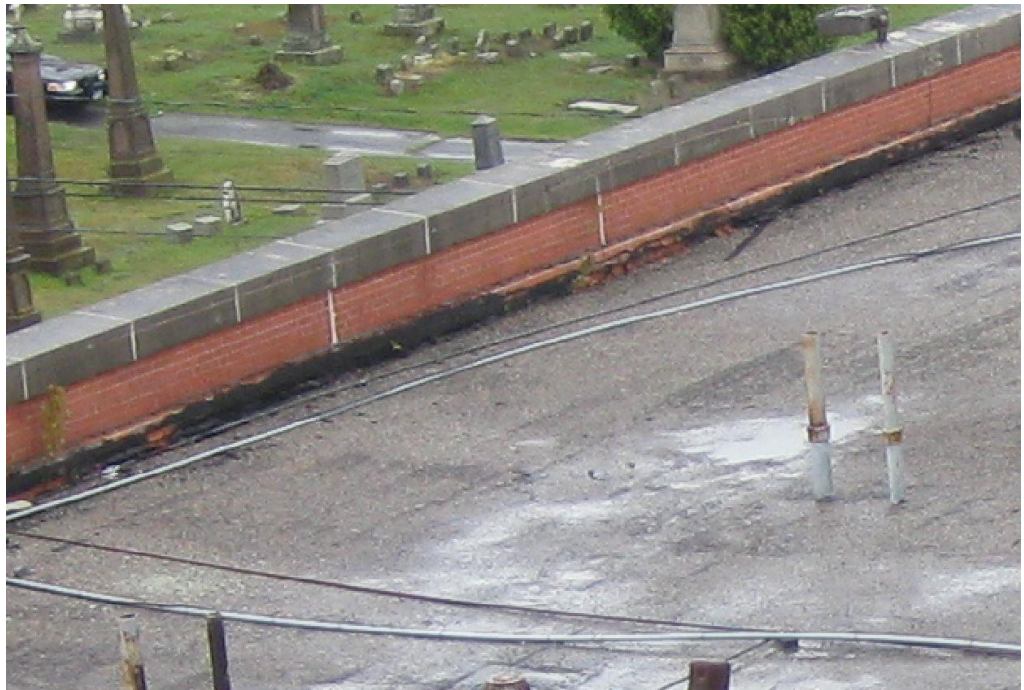
Photo B-2 – Failed flashing at 1966 Addition

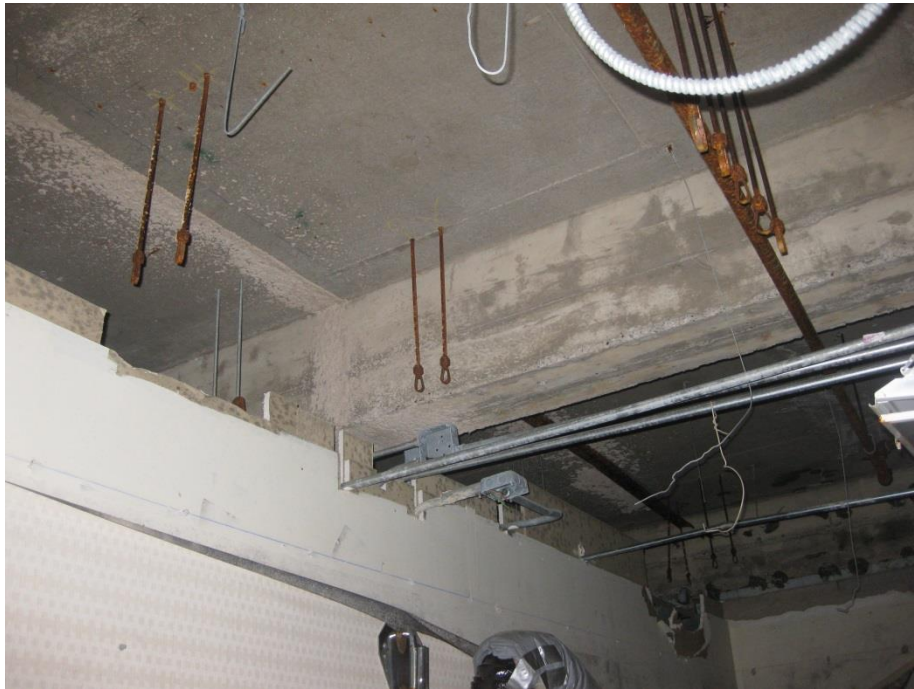
Photo B-3 – Exposed Structure at 1966 Addition

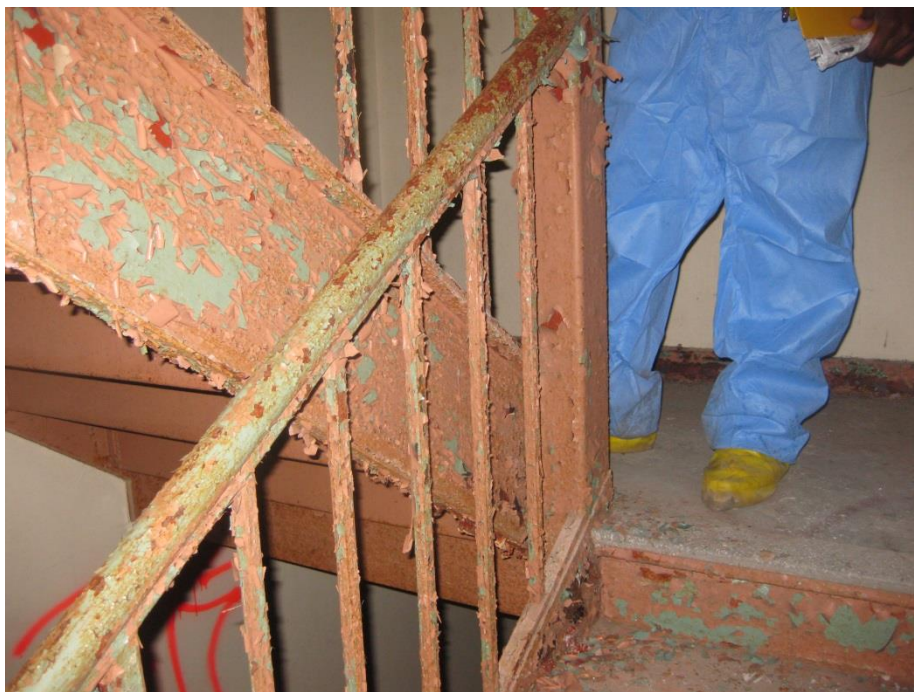
Photo B-4 – Damaged Miscellaneous Steel

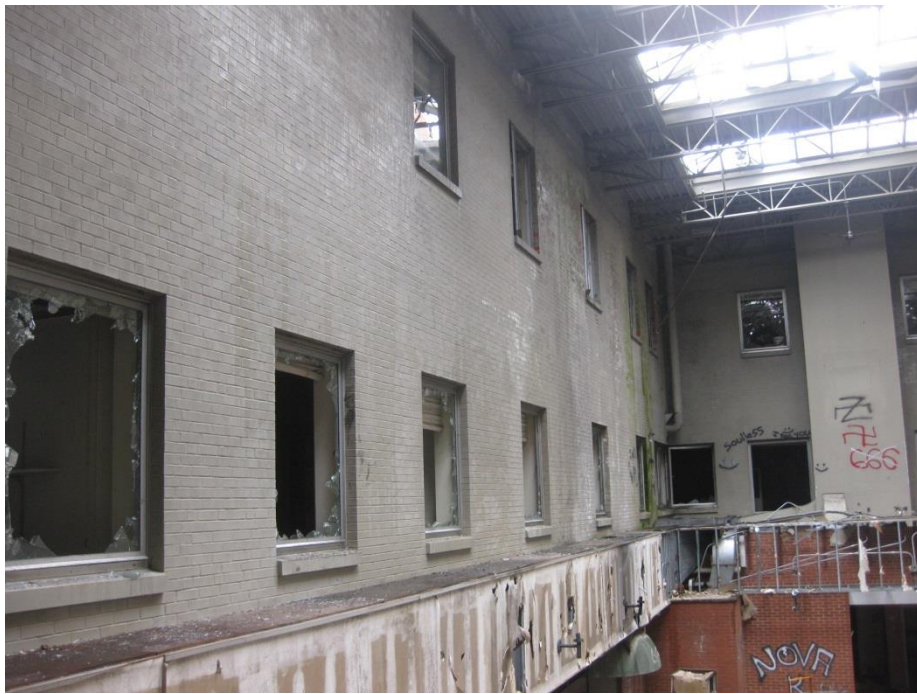
1. The majority of the floor and roof structures are concealed by plaster walls and ceilings and cannot be directly observed, but generally floor structures appear to be sound.
2. An atrium that had previously been an exterior courtyard when the 1966 addition was constructed has a series of skylights above that are severely damaged, allowing water to enter the building and cause damage to finishes and structures (see photos B-1 and C-1).
3. A portion of the elevator penthouse of this section was added on top of the original building, with an expansion joint extending through at the interface with the south addition. The expansion joint has failed, permitting infiltration of water (see photo C-2).

Photo C-1 – Water Damage at Atrium

3. Cover damaged skylights at atrium.
 4. Wire brush all steel framed platforms in mechanical rooms, rooftop equipment dunnage, stairs and handrails in order to assess the extent of material loss.

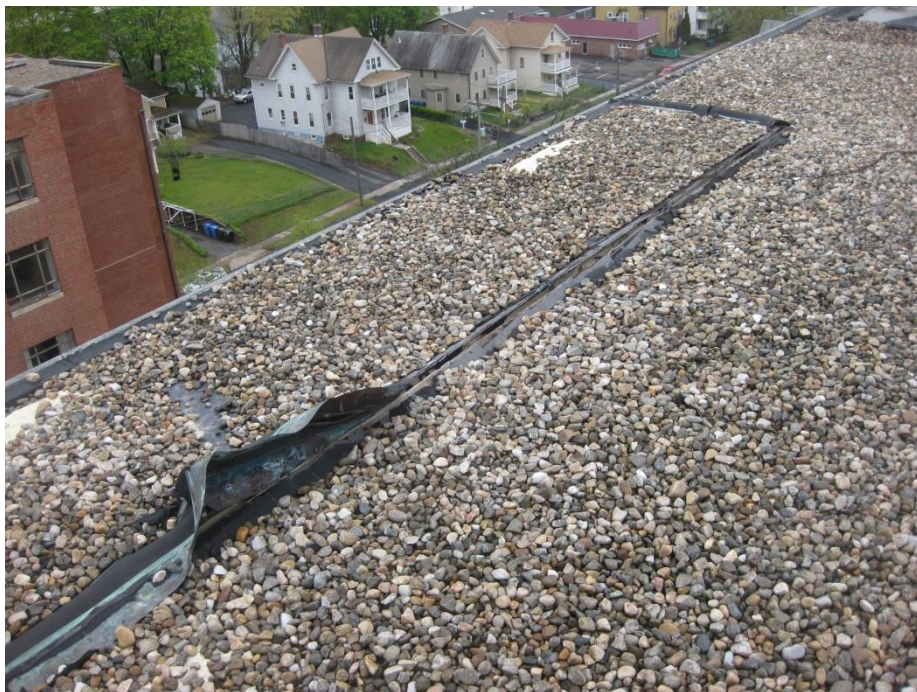
Photo C-2 – Expansion Joint at Penthouse Roof

1. Remove all damaged interior finishes to permit full visual inspection of floor and roof structures.
 2. Restore the building envelope (including windows, roofing, expansion joints and flashing) to prevent infiltration of water that can cause further damage to structures.

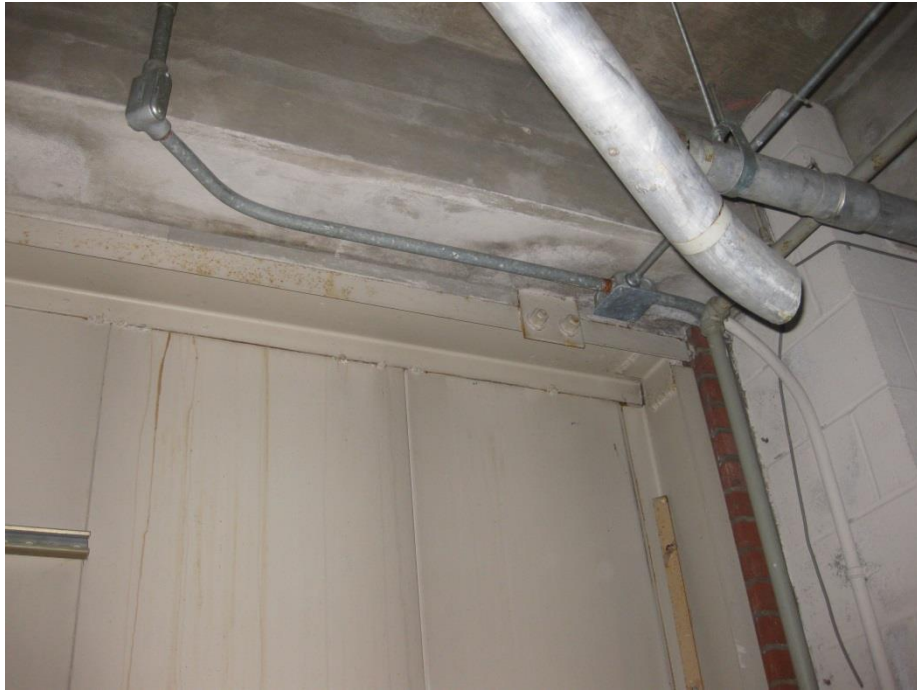
1. The prefab penthouse has failed roofing, which has caused the metal framing to begin to corrode (see photo D-1).
2. On the fourth floor there is a significant drain blockage. Resulting standing water has entered the building, destroyed the finished ceiling and left significant ponding on the floors during the time of visit (see photo D-2).

Photo D-1 – Water Infiltration at Penthouse at 1952 Addition

1. Remove all damaged interior finishes to permit full visual inspection of floor and roof structures.
 2. Restore the building envelope to prevent infiltration of water that can cause further damage to structures.
 3. Wire brush all steel framed platforms in mechanical rooms, rooftop equipment dunnage, stairs and handrails in order to assess the extent of material loss.
 4. Repair or replace miscellaneous steel structures as appropriate.
 5. Repoint exposed exterior brick as needed.
 6. Replace all existing roofs and flashing.
- E. The 1958 addition has steel framed construction encased in concrete supporting cast in place reinforced concrete floor joists. The roof is ballasted.

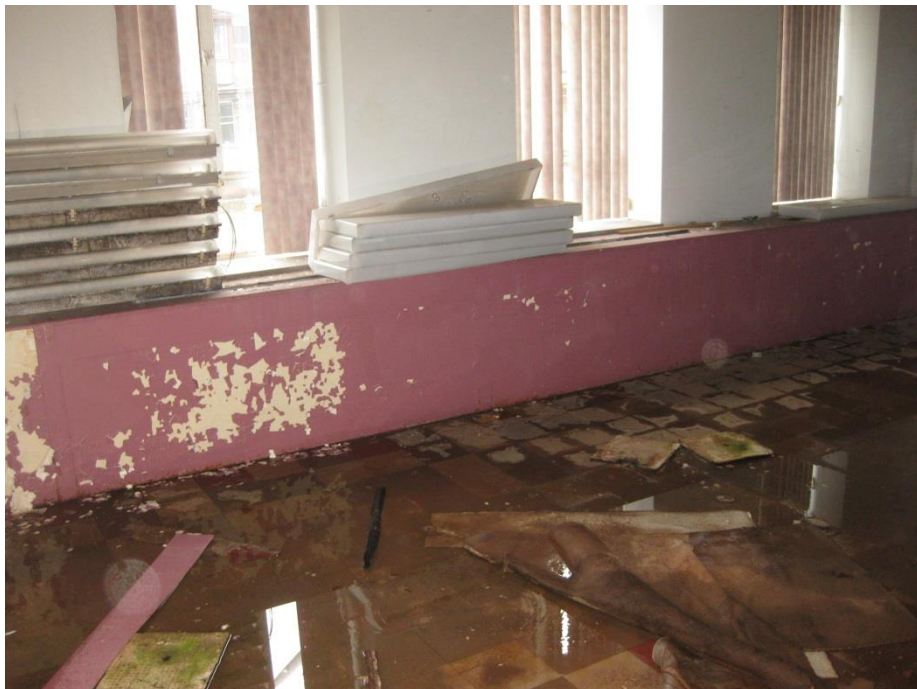
Photo D-2 – Water Damage at 1952 Addition

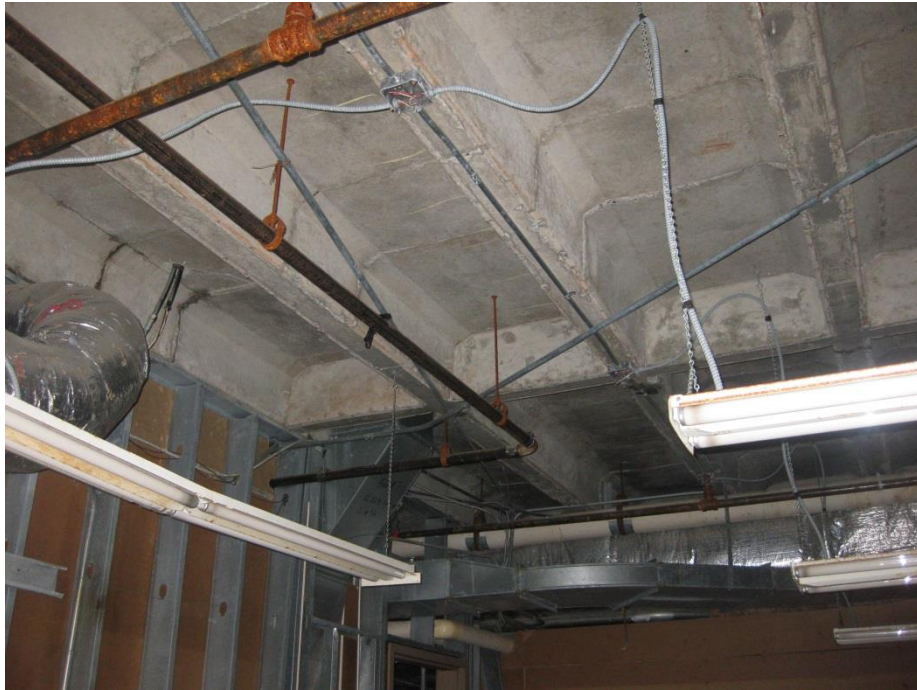
3. The majority of the structural system is concealed by interior finishes and cannot be directly observed, but generally floor structures appear to be sound. Areas that are exposed generally appear to be in good condition (see photo D-3).

Photo D-3 – Exposed Structure at 1952 Addition

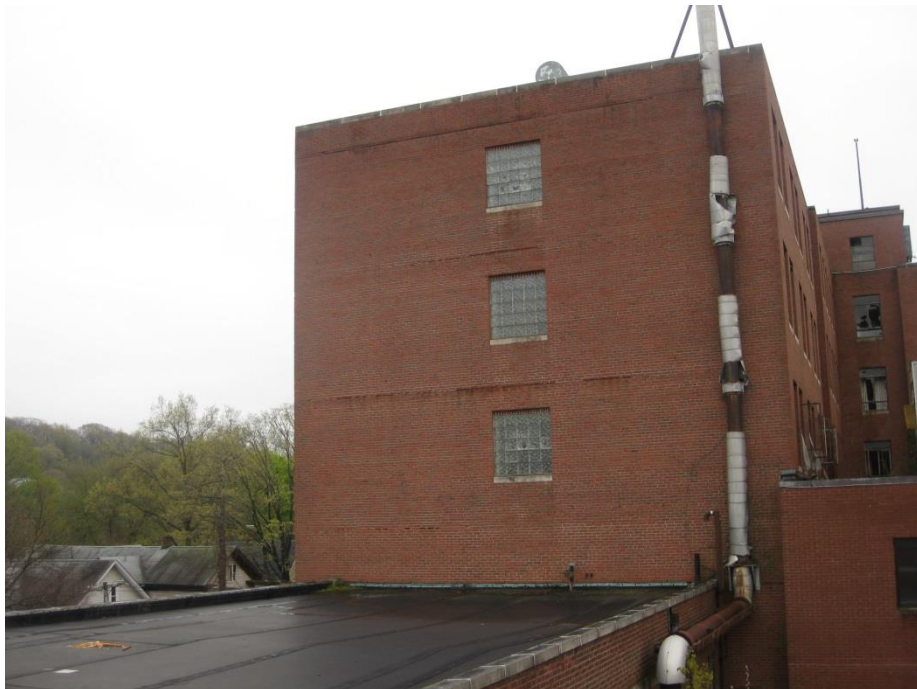
1. Rust and rust jacking of exterior brick was observed at the north wall of the addition (see photo E-1). This likely resulted from roof failure and infiltration of water along the interior of the wall, causing perimeter steel floor beams to rust.
2. The majority if the structural system is concealed by interior finishes and cannot be directly observed, but generally floor structures appear to be sound.

Photo E-1 – Rust Jacking at North Wall of 1958 Addition

4. Repair or replace miscellaneous steel structures as appropriate.
 5. Repair or replace damaged lintels, exterior brick and associated flashing where rust jacking has been identified.

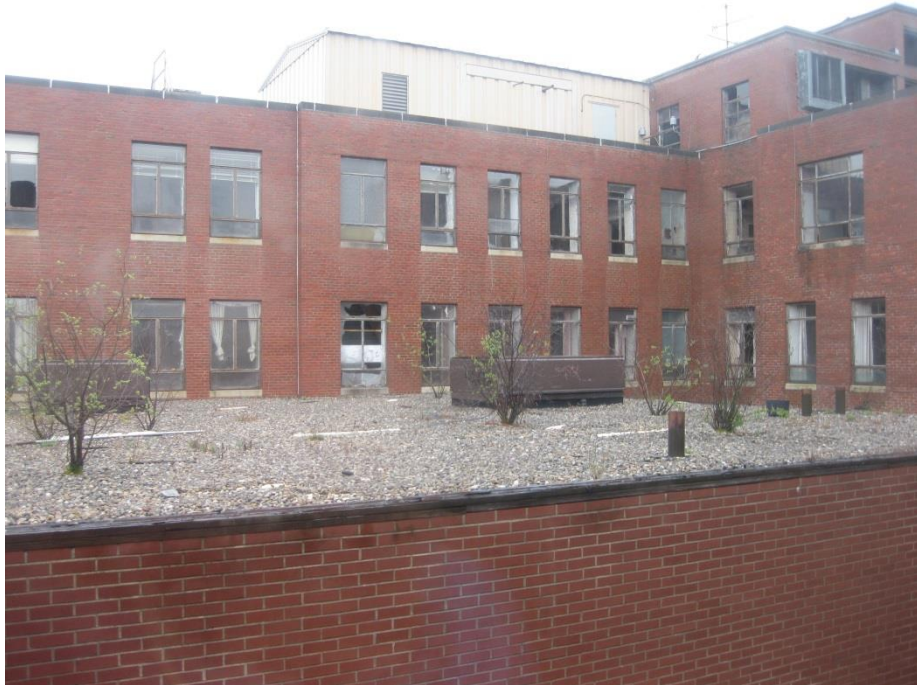
1. Most of the structural systems are concealed by interior finishes and cannot be directly observed. Water infiltration is evident throughout, but generally floor structures appear to be sound.
2. There is a large amount of mature vegetation growth over many areas of the roof, indicating long term roof failure (see photo F-1).
3. There is a canopy connected to the North Addition at a loading dock facing the courtyard shared by the rear of the Nurses Home. The built up roofing and flashings have failed at the canopy, causing water damage below (see photo F-2).

Photo F-1 – Roofing at North Addition

1. Remove all damaged interior finishes to permit full visual inspection of floor and roof structures.
 2. Restore the building envelope to prevent infiltration of water that can cause further damage to structures.
 3. Repoint exposed exterior brick as needed.
 4. Replace all existing roofs and flashing.
- G. The South Addition is the largest expansion to the hospital in terms of the building footprint. The building perimeter ranges from the drive up access on King Place to the storefront section located on Cook Avenue. It is steel framed construction with concrete floor slabs on metal deck. The roof is ballasted.

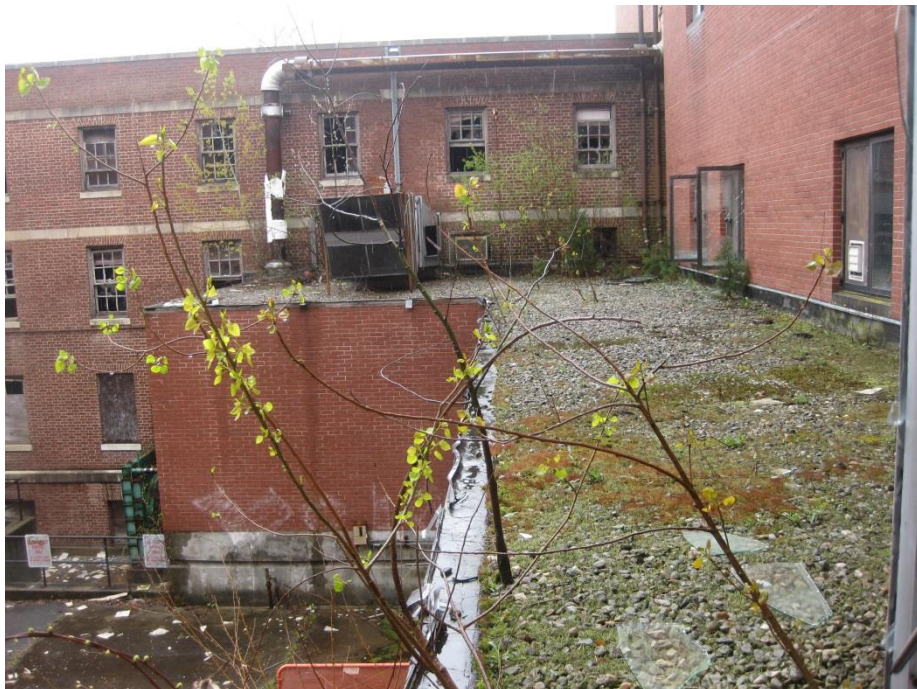
Photo F-2 – Roofing at Loading Dock Canopy

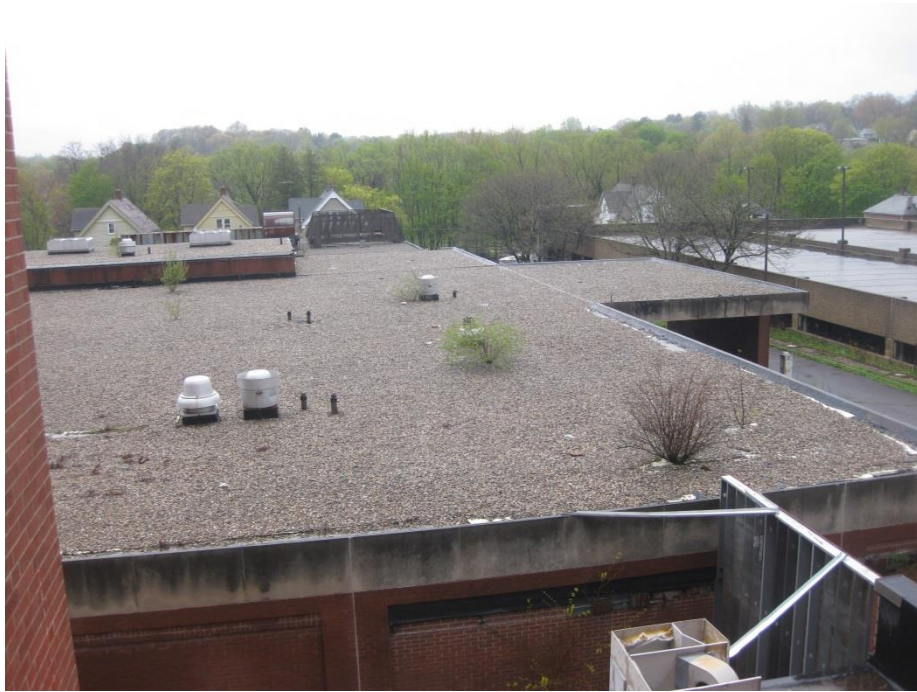
1. Vegetative growth was observed throughout the roof of the South Addition (see photo G-1), exacerbating roof failure and water infiltration.
2. The canopy structure on King Place is in poor condition. The roof has failed, which has caused corrosion on the framing beams and connections (see photo G-2).
3. On the first floor on the King Place side, ponding water was found on the floor, indicating clogged roof drains and water infiltration at walls. Early stages of corrosion were noted at the structural steel and roof deck. Generally, the corrosion has not progressed to the point where the structure is compromised.

Photo G-1 – Roofing at South Addition

1. Remove all damaged interior finishes to permit full visual inspection of floor and roof structures.
2. Restore the building envelope to prevent infiltration of water that can cause further damage to structures.
3. Repair or replace damaged elements at canopy.
4. Wire brush all steel framed platforms in mechanical rooms, rooftop equipment dunnage, stairs and handrails in order to assess the extent of material loss.

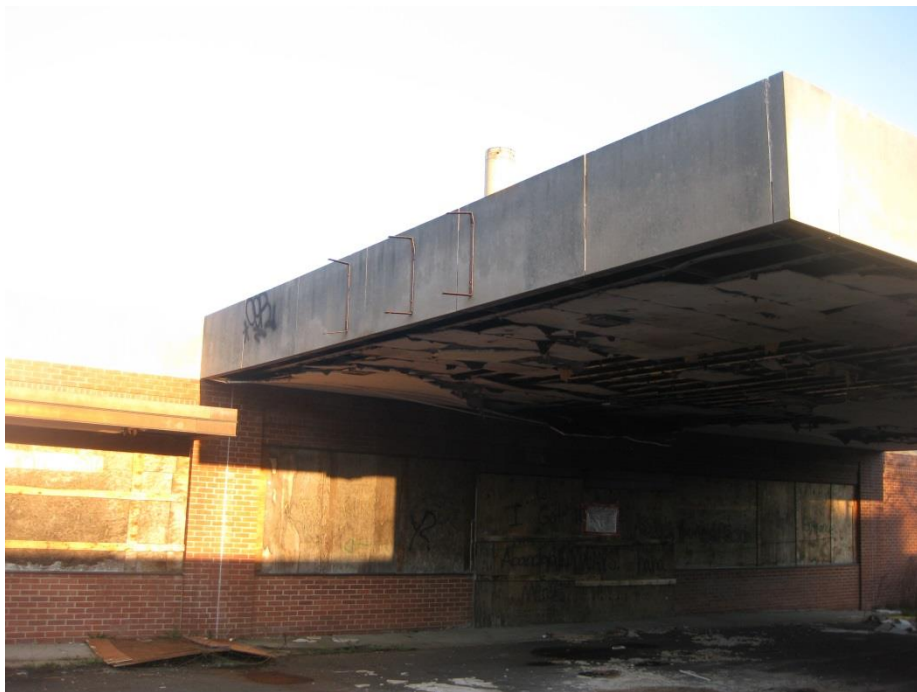
Photo G-2 – Canopy at King Place Entrance

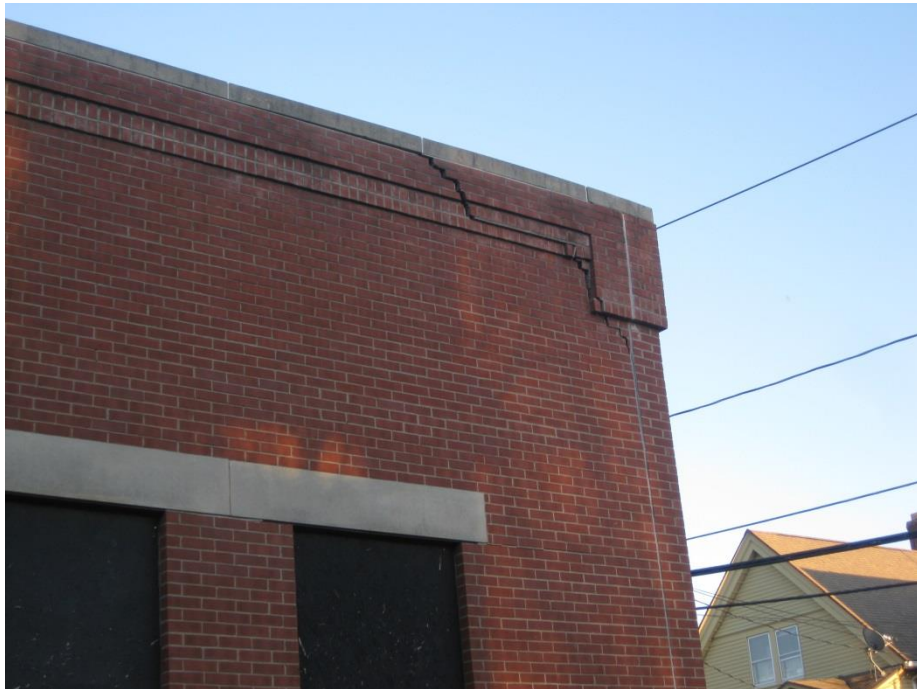
1. On the first floor on the King Place side, there are drainage issues that are likely a result of clogged roof drains. It has left areas ponding and some vegetation.
2. The exterior brick has a large crack at the corner where the walls intersect at the southwest corner at the intersection of King Place and Bronson Avenue (see photo H-1). The cracks extend diagonally from the top of the walls along each side and meet at the corner. They do not progress far below the roof. This is likely due to water infiltration and freeze-thaw action, possibly combined with rust jacking at the perimeter framing.

Photo H-1 – Cracked Brick at Corner of Laundry/Storage Addition

4. Repair or replace miscellaneous steel structures as appropriate.
 5. Repair damaged exterior brick at the southwest corner of the building.
 6. Repoint exposed exterior brick as needed.

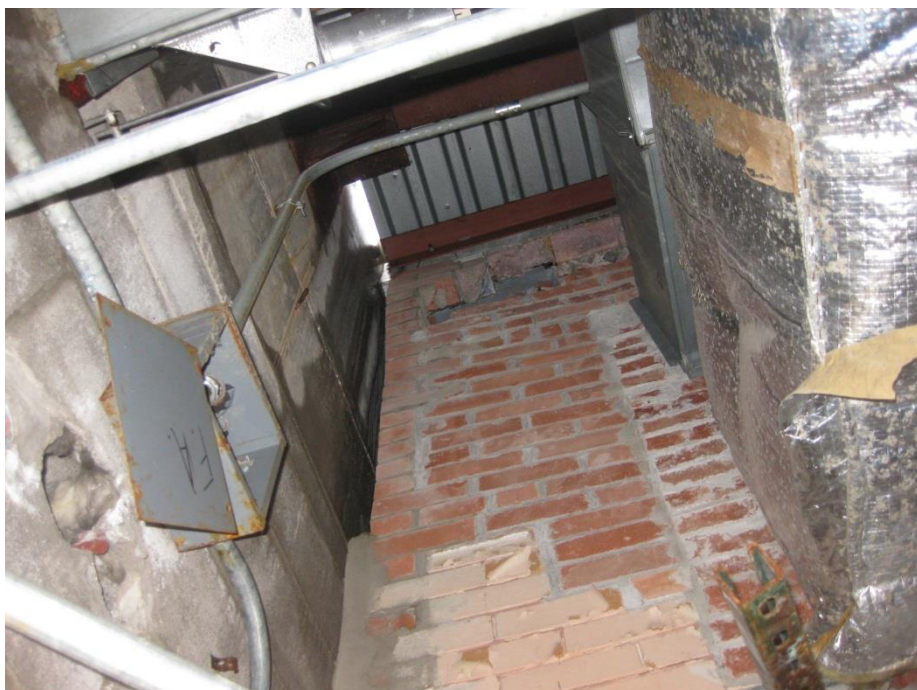
1. The joint that connects the roof of the Laundry/Storage to the 1968 section of the Boiler room has completely failed. The infiltrating rainwater in the building has caused surface rust and pitting in the steel beams (see photo I-1).

Photo I-1 – Water Infiltration at Expansion Joint

1. Remove all damaged interior finishes to permit full visual inspection of floor and roof structures.
2. Replace damaged deck and beams.
3. Restore the building envelope to prevent infiltration of water that can cause further damage to structures.
4. Cover damaged skylights.
5. Wire brush all steel framed platforms in mechanical rooms, rooftop equipment dunnage, stairs and handrails in order to assess the extent of material loss.
6. Repair or replace miscellaneous steel structures as appropriate.
7. Repair or replace damaged lintels, exterior brick and associated flashing where rust jacking has been identified.
8. Repoint exposed exterior brick as needed.
9. Replace all existing roofs and flashing.

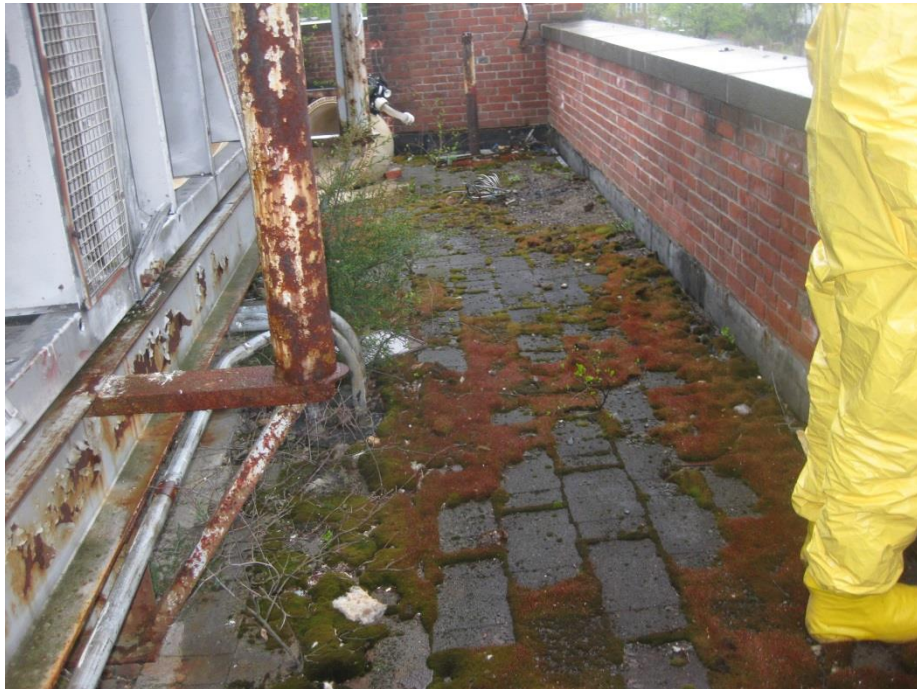
2. In the 1968 section there is a large amount of ponding water that is likely the result of failed roofing and flashing and clogged roof drains.
3. In the 1968 section the roof has significant vegetation growth and is in poor condition (see photo I-2).

Photo I-2 – Roofing Failure at Boiler Plant

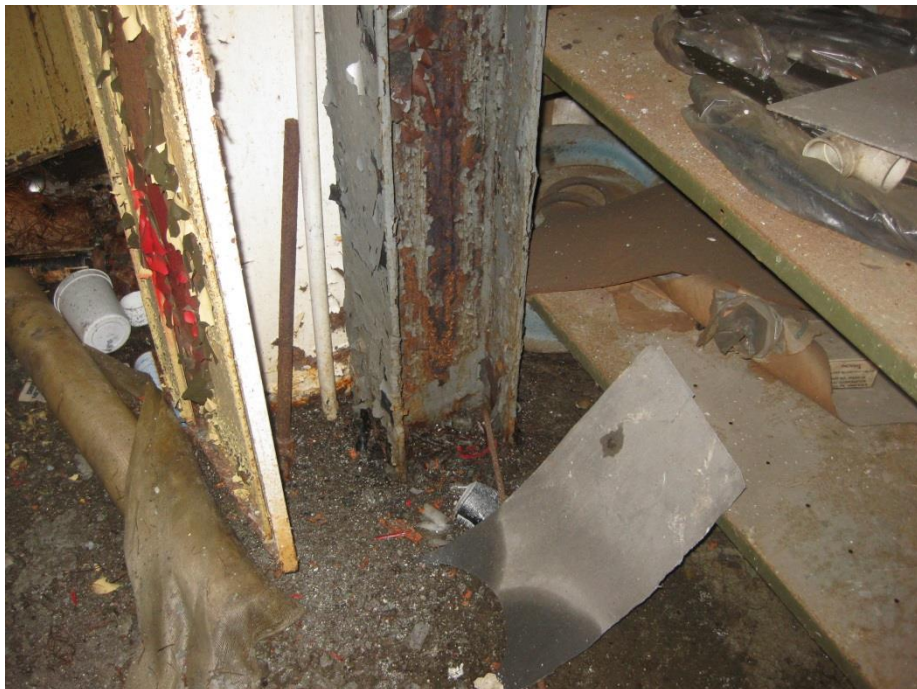
4. In the 1968 section multiple columns have severe corrosion and failed base plates (see photo I-3).
5. In the older section there is a pipe crawl space that is filled with approximately 5 inches of standing water, indicating severe water infiltration and drainage issues (see photo I-4). All of the miscellaneous steel in this section has been exposed to standing water over a long period of time, and consequently is corroded and in need of replacement.

Photo I-3 – Corrosion at Steel Columns and Baseplates

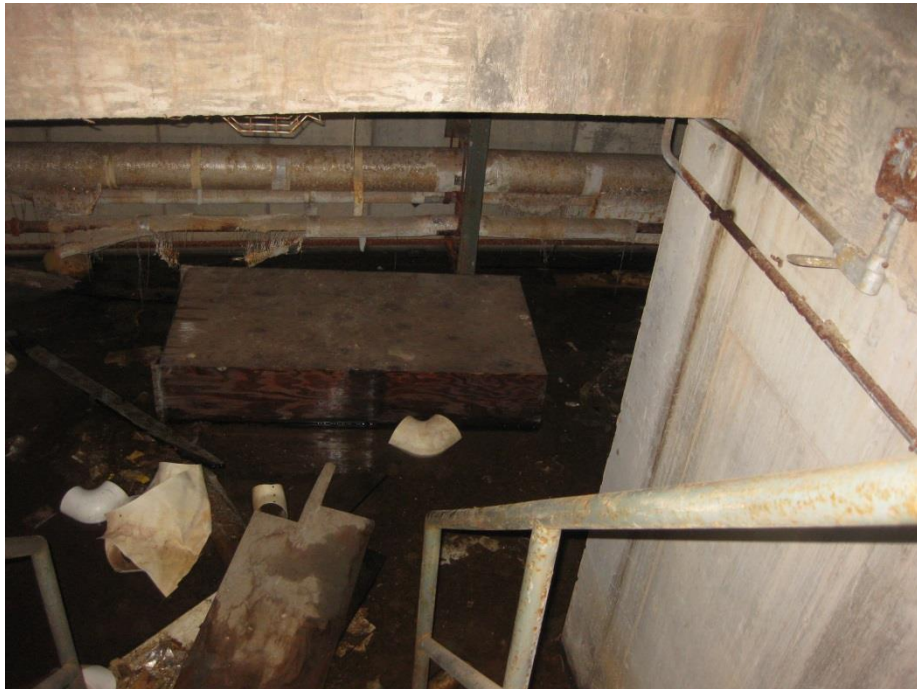
Photo I-4 – Standing Water at Pipe Tunnel

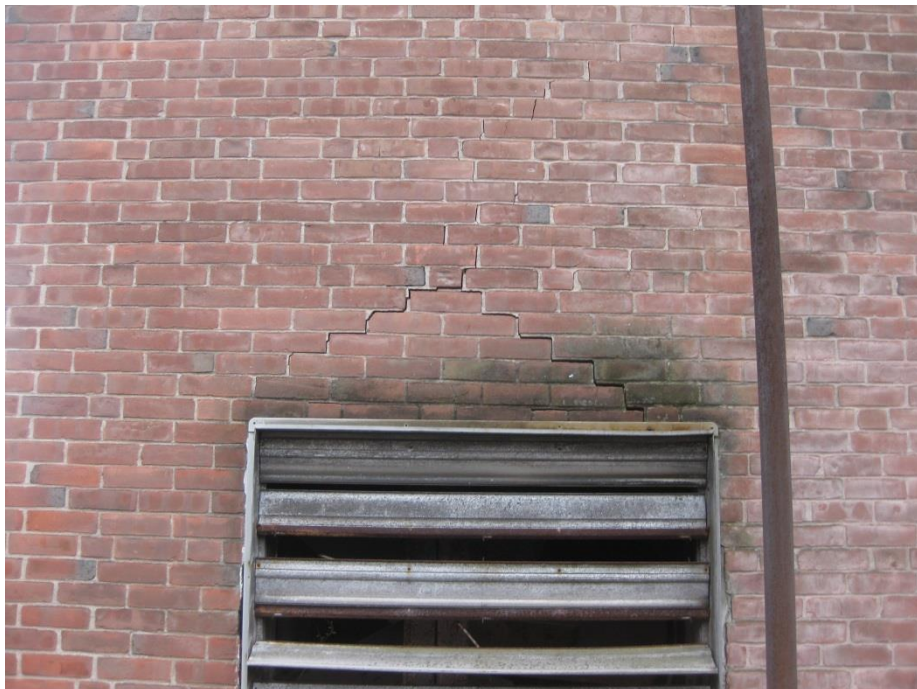
6. In the 1968 section, masonry is failing above a wall vent on the east wall (see photo I-5). There does not appear to be a lintel at this location.
7. In the older section of the boiler room, the eastern masonry wall has a failed lintel, and the exterior brick has started to bow (see photo I-6). This occurs at a point where the wall openings have been modified several times, likely resulting in failure of the flashing. This has led to water infiltration, causing mortar failure, rust jacking and freeze thaw damage.

Photo I-5 – Failed Masonry at Vent Opening

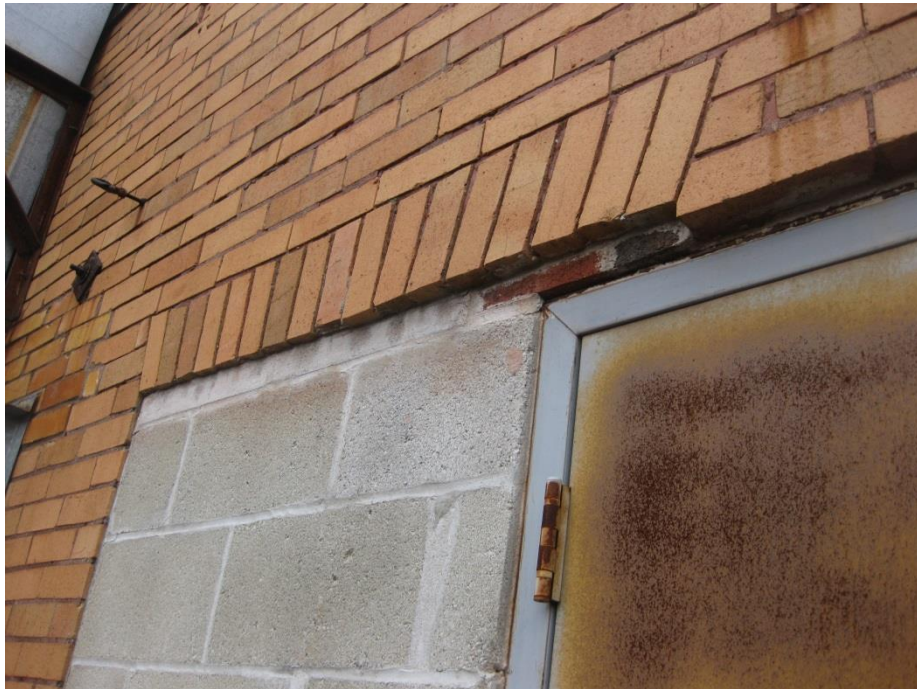
Photo I-6 – Bowed Masonry at Modified Door Opening

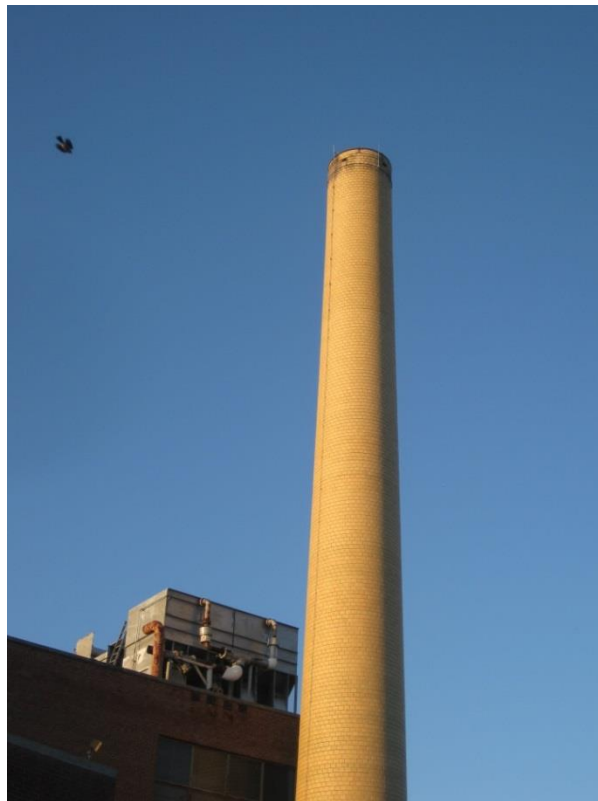
8. The brick construction of the stack near the southeast corner of the boiler room appears to match the 1923 building, and likely dates back to that time. The condition of the stack appears generally good, but some dislodged brick and missing mortar was noted in the upper portions of the stack (see photos I-7 and I-8). This should be addressed or the stack removed in conjunction with any building renovations.

Photo I-7 – Stack

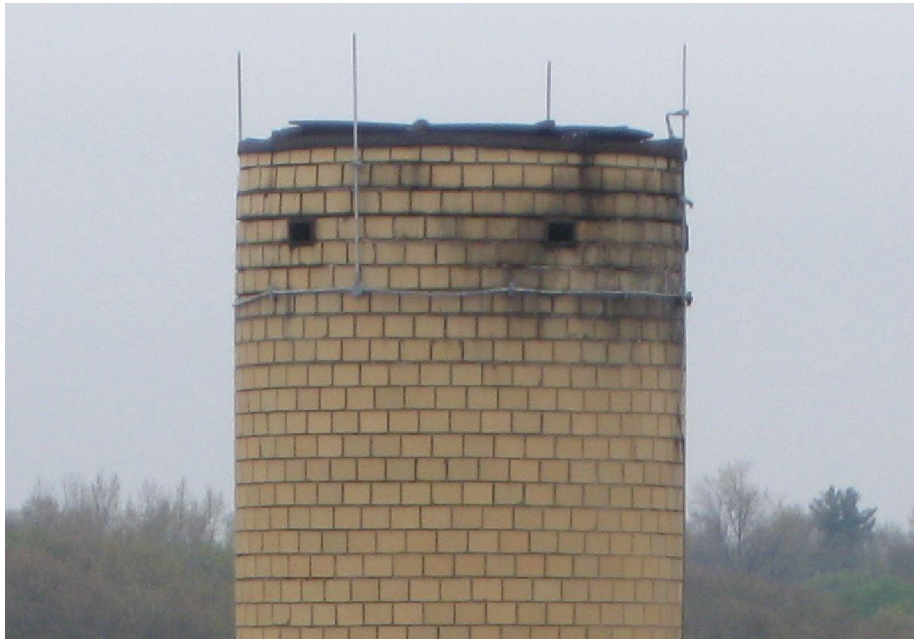
Photo I-8 – Top of Stack
