Structural Condition Report

City of Meriden
Former Meriden Hospital
1 King Place
Meriden, CT 01040

May 23, 2016

Project No. 20120232.C50

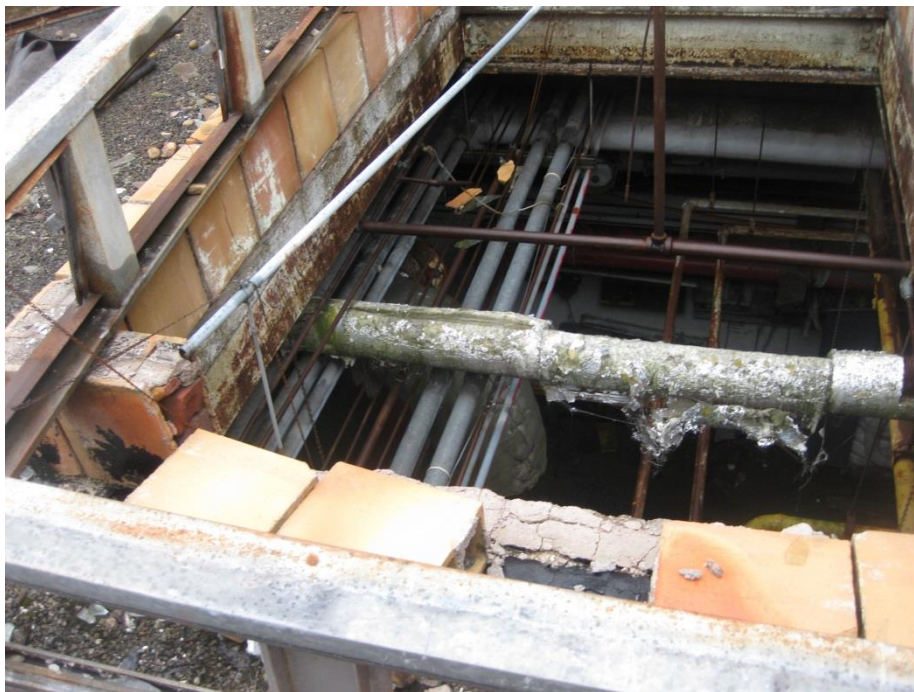
9. A skylight in the 1923 portion of the boiler room has been removed from the roof, leaving the area open to the elements (see photo I-9). Significant water damage was found at the roof structure and interior space in this area.

Photo I-9 – Open Skylight at Boiler Room

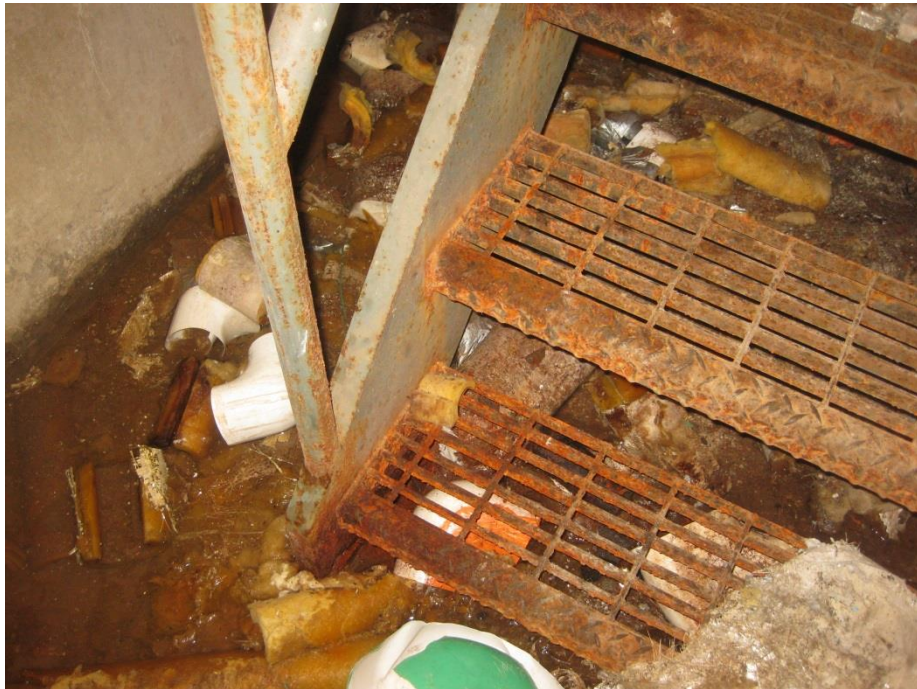
10. At several locations, interior steel grating stairs terminate in standing water (see photo I-10). Many of the treads and stringers of these stairs are severely corroded.

Photo I-10 – Damaged Stairs at Boiler Room

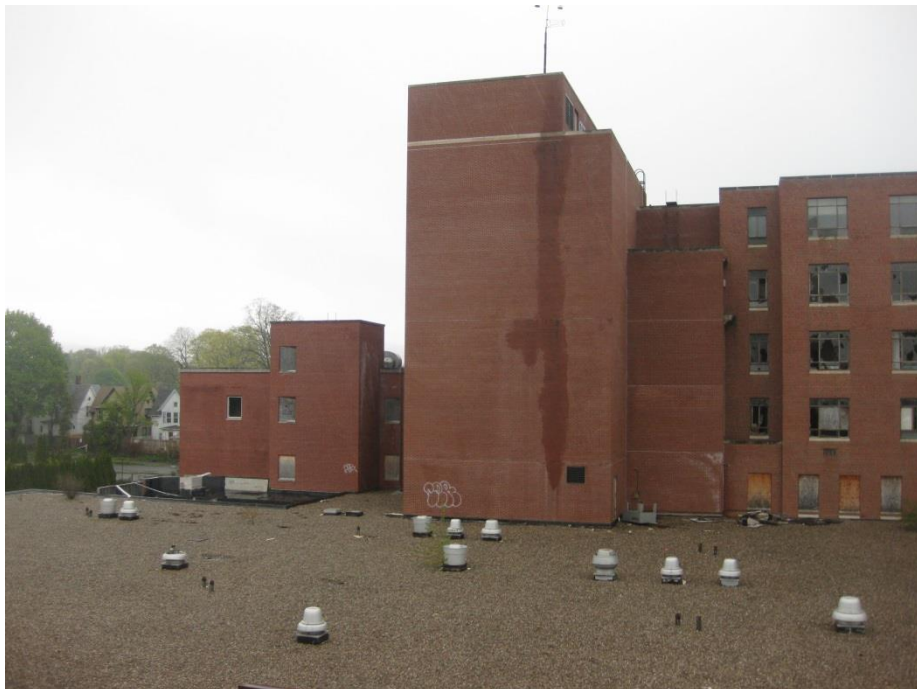
1. Water infiltration was commonly noted at stair towers, resulting from failure of roofing and flashing. Building structures and stairs at the newer towers were generally not significantly damaged.
2. Some efflorescence and rust jacking was noted at lintels at the stair towers (see photo J-1).

Photo J-1 – Water Infiltration and Rust Jacking at Stair Tower

1. Remove all damaged interior finishes to permit full visual inspection of floor and roof structures.
2. Restore the building envelope to prevent infiltration of water that can cause further damage to structures.
3. Wire brush all stairs and handrails in order to assess the extent of material loss.
4. Repair or replace miscellaneous steel structures as appropriate.
5. Repair or replace damaged lintels, exterior brick and associated flashing where rust jacking has been identified.
6. Repoint exposed exterior brick as needed.
7. Replace all existing roofs and flashing.

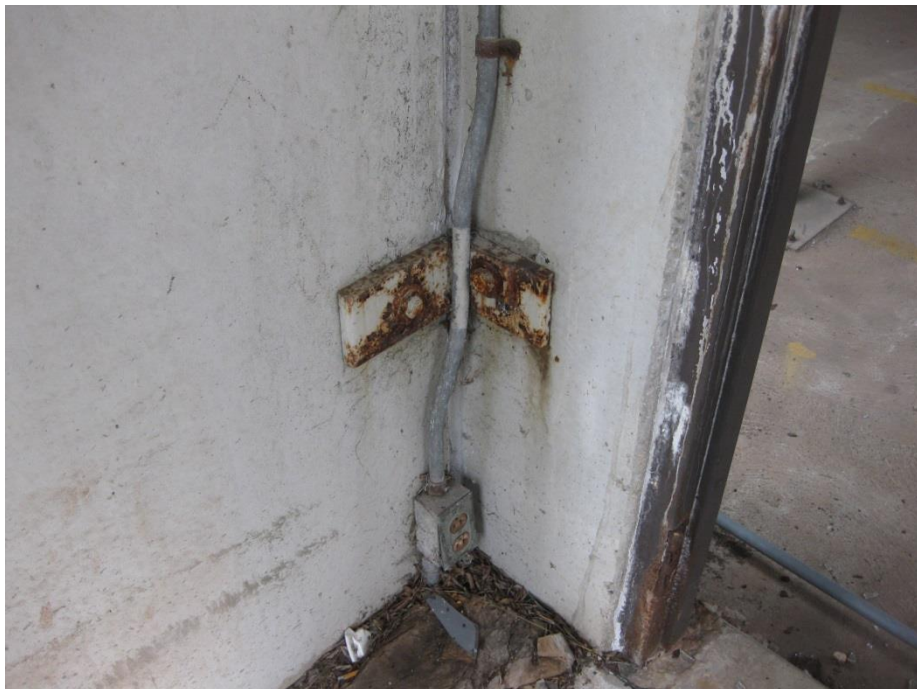
1. Many of the miscellaneous steel elements show evidence of corrosion and some are in poor condition. These items include connection angles, door frames, railings and support frames at drains (see photo K-2).

Photo K-2 – Corroded Steel at Stairwells

1. Wire brush all steel elements in order to assess the extent of material loss.
2. Repair or replace steel angles and stair elements as appropriate.
3. Perform thorough evaluation of concrete surfaces following removal of all debris to assess the need for rehabilitation.
Repair concrete surfaces that have spalled or demonstrate evidence of delamination. Some rebar replacement is anticipated in conjunction with this work.
4. Replace expansion joints and control joints between precast elements at all levels as required.

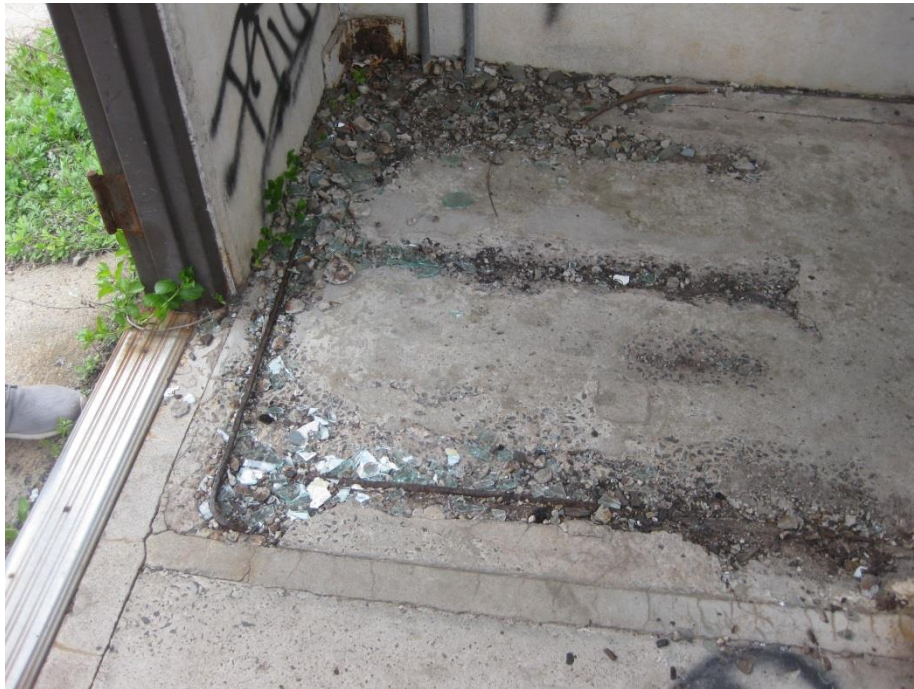
2. The north stairwell concrete at the platforms is in poor condition. There is exposed rebar at the platform adjacent to the east exit (see photo K-3). The concrete is spalled and delaminated in multiple areas heading to the top floor and second floor.

Photo K-3 – Damaged Concrete at Stair Platform

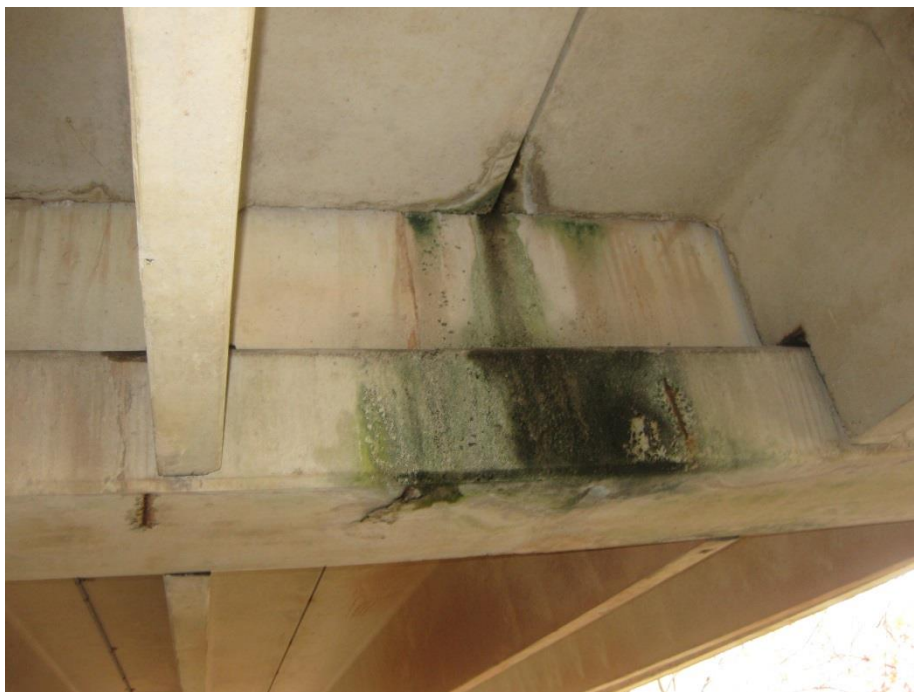
3. Many of horizontal joints have completely failed. About 40% of Vertical Joints on the top floor between the columns and exterior wall have failed (see photo K-4).

Photo K-4 – Failed Joints Between Precast Elements

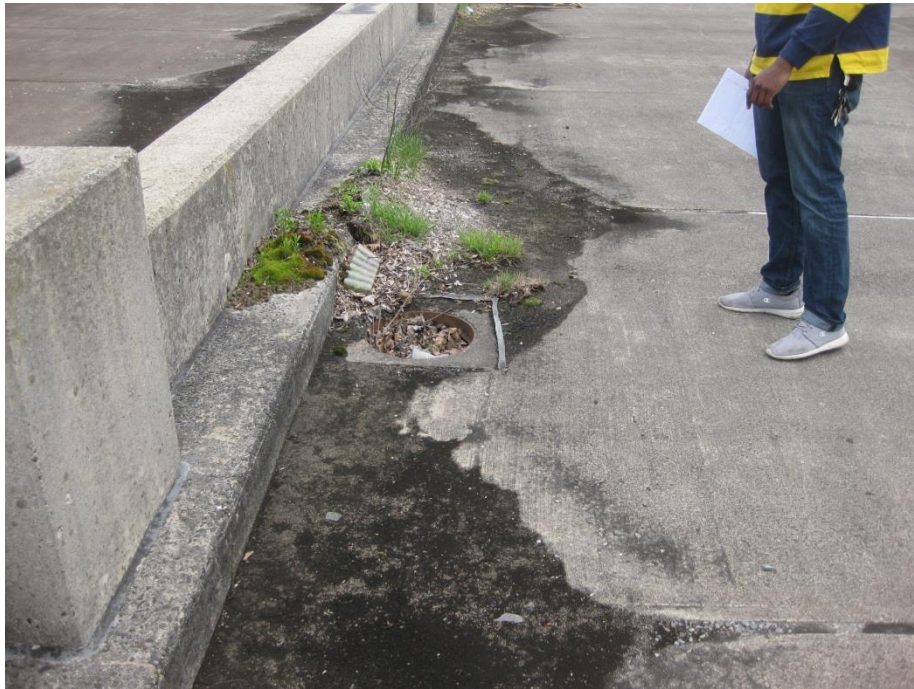
4. All of the top floor drains are filled with debris and are nonoperational (see photo K-5). The resulting flooding has caused damage to the concrete reinforcement on most areas between joints. The water has also corroded and degraded the drain support framing and precast tee bearing plates at the interior girders above the ground floor (see photo K-6).

Photo K-5 – Clogged Roof Drains

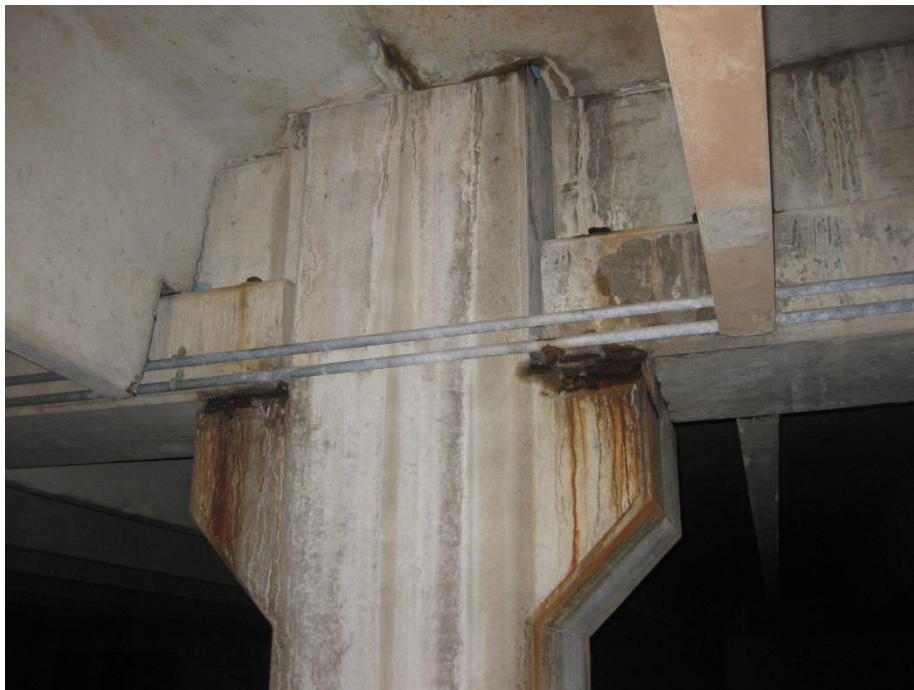
Photo K-6 – Rust at Bearing Plates

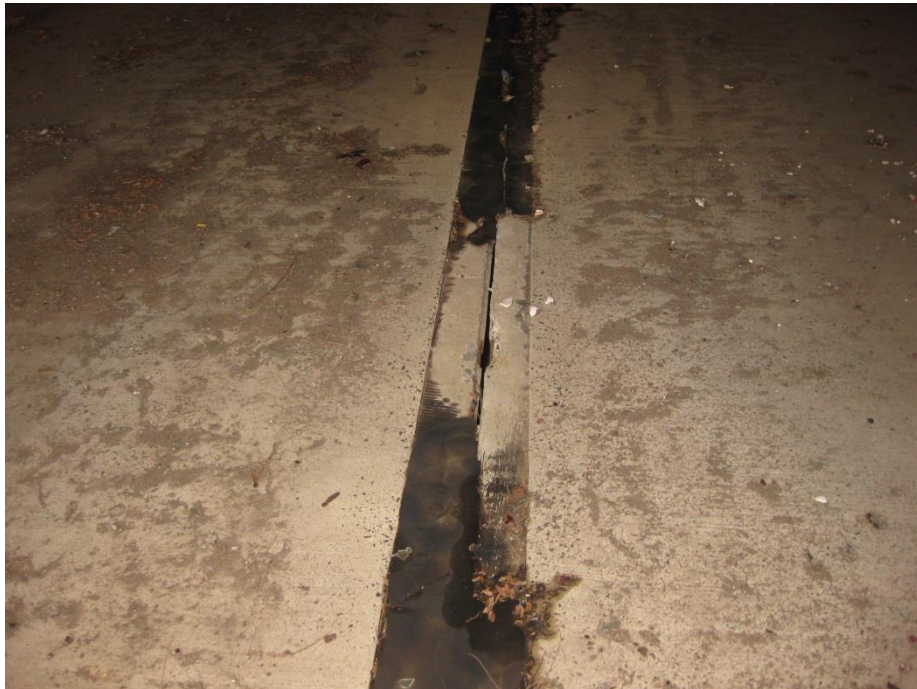
5. There is a single expansion joint across the center of the structure. The joint has failed, allowing infiltration and water and associated damage below (see photo K-7).
6. A limited acoustic emissions test was performed at the top surfaces of the garage slabs. The test consisted of movement of a steel chain apparatus across the top surfaces to identify delamination of the concrete by sound. Only limited areas of delamination were identified, typically at stair tower platforms and near entrances to the garage.

Photo K-7 – Failed Expansion Joint
